REPORT OF COMPLIANCE EVALUATION INSPECTION  
(CONSTRUCTION STORM WATER)

**Glynn Village Plat 10**

Waukee, Iowa 50263

OCTOBER 12 AND 14, 2016

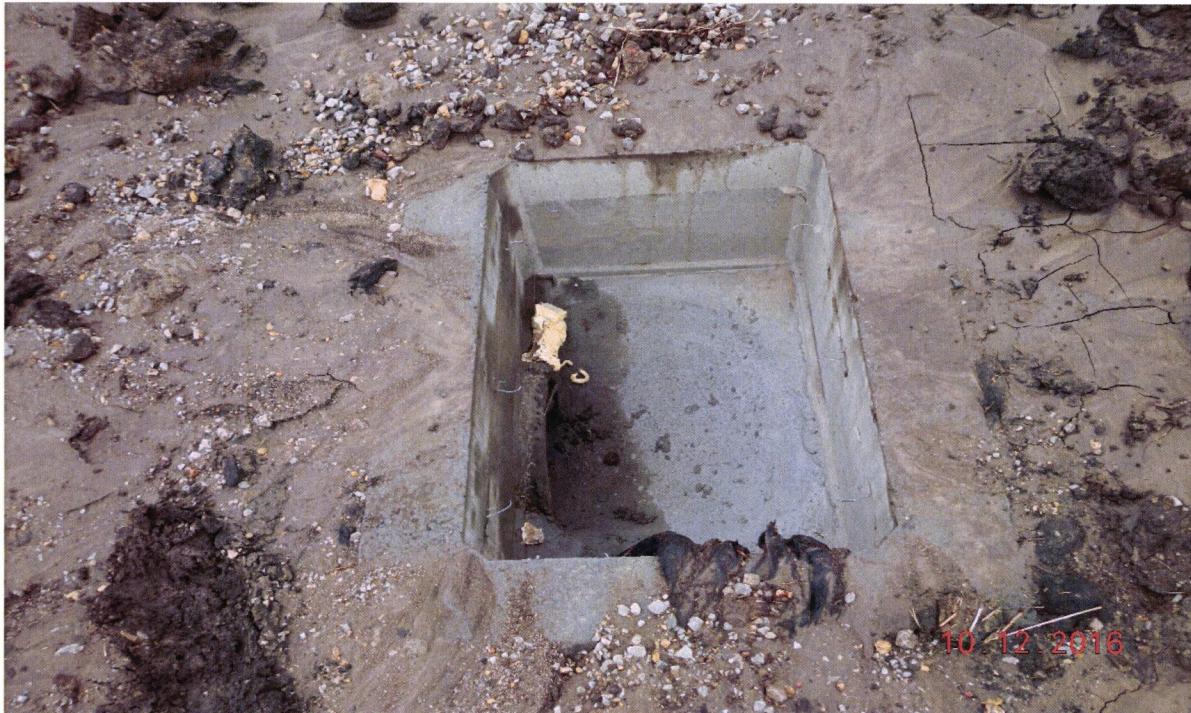
**DSCN 1714, Stormwater Inlet #4 with no controls.**

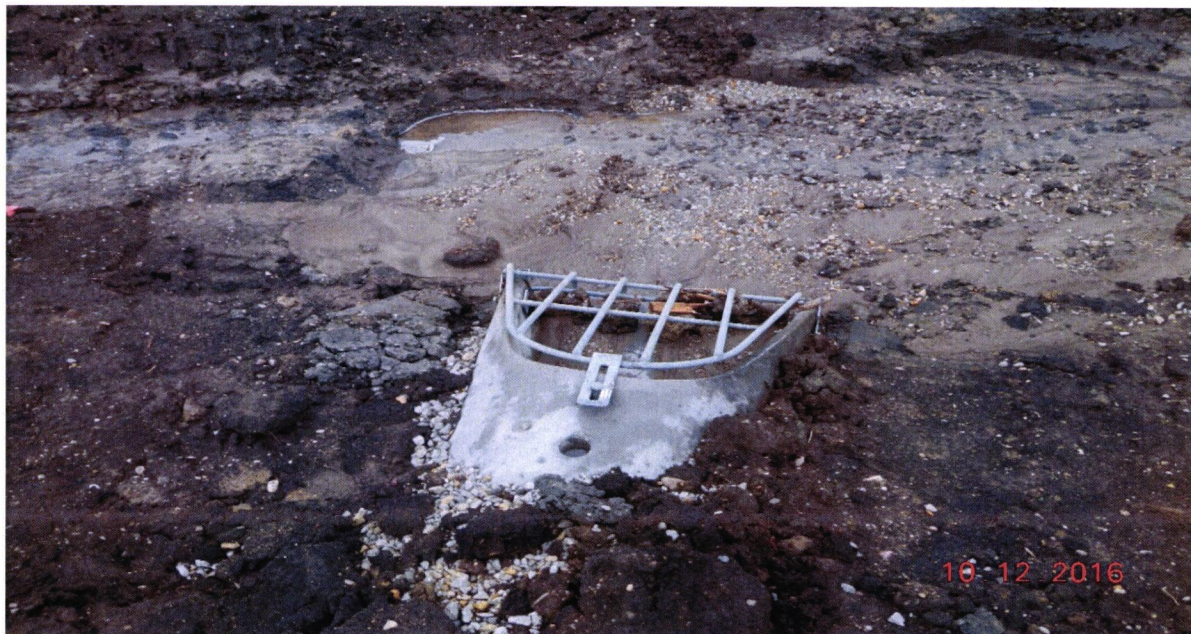
**DSCN1715, Outlet #4 of the stormwater inlet above discharging in the south ditch.**

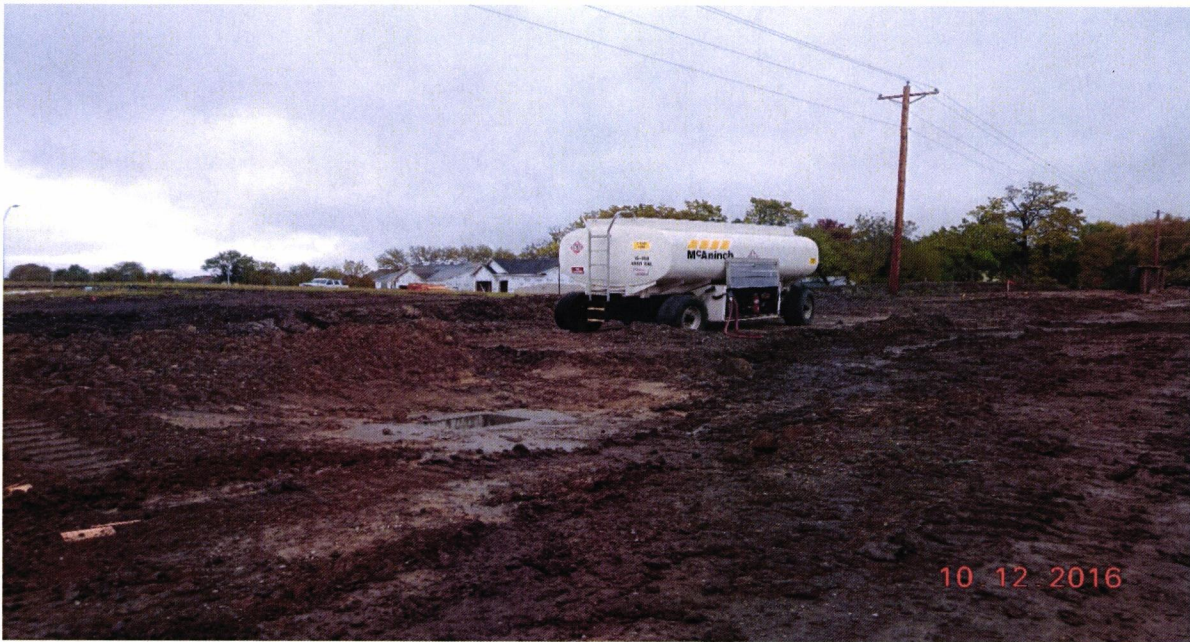
10. I observed a 4,000 gallon diesel fuel tank (without any containment) parked a few feet from one of the unprotected stormwater inlets (inlet #2 shown in attachment 2) as shown in DSCN1711 below. Therefore, I issued notice of potential violation number 4 (NOPV #4) because Hubbell Development failed to place the diesel fuel tank within a secondary containment (DSCN1706, 1708, and 1711).

**DSCN1711, diesel fuel tank few feet from an unprotected stormwater inlet #2.**

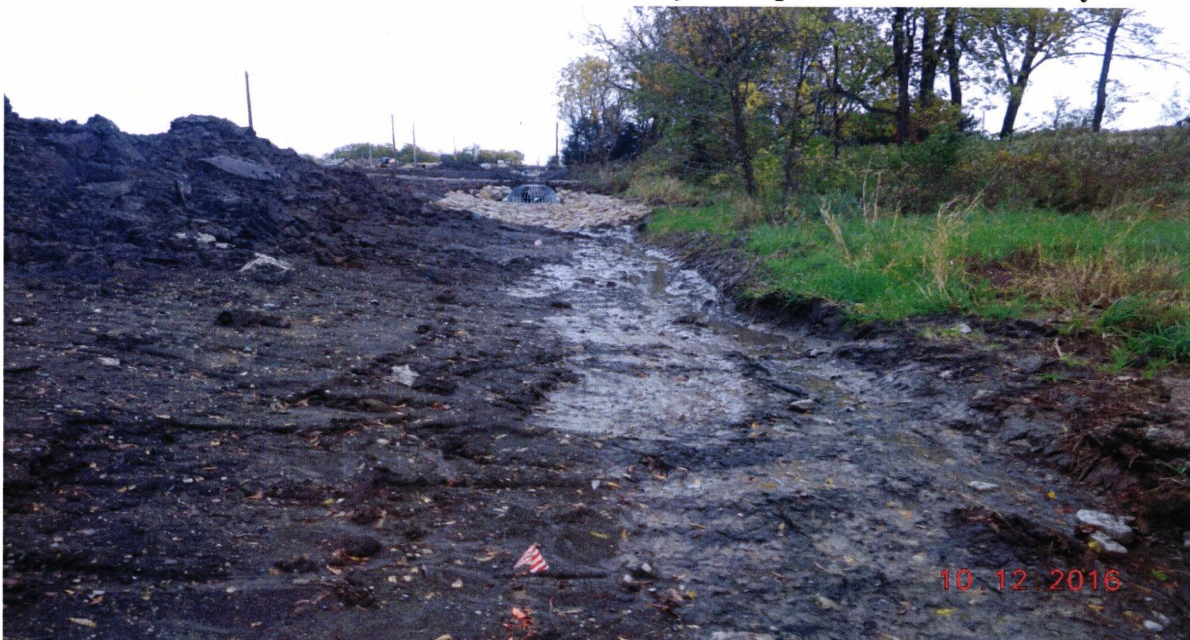
12. Based on my visual observation of lack of sediment and erosion controls at the Westtown Parkway road project, I issued NOPV #1 because Hubbell Development failed to install sediment and erosion controls around the stormwater inlets and in the south ditch as required by the SWPPP and the NPDES permit.
13. I visually inspected the unnamed tributary, especially at the discharge point from the south ditch (DSCN1730, DSCN1737). At that location, I observed evidence of a significant amount of sediment in the south ditch downhill toward the tributary as shown in DSCN1731.

**DSCN1731, Sediment in the south ditch few yards upstream from tributary.**

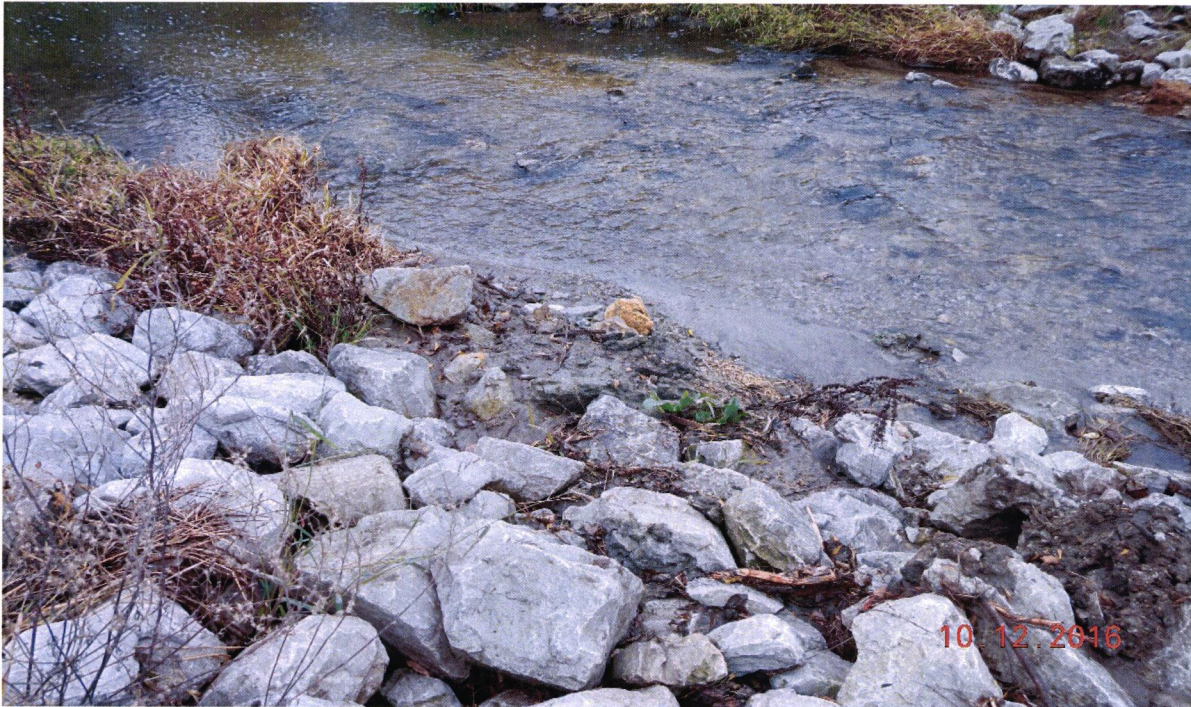
In addition, I observed significant accumulation of sediment on the east bank of the tributary and in the tributary as shown in DSCN1736 below.

**DSCN1736, Sediment on the bank and in the tributary.**

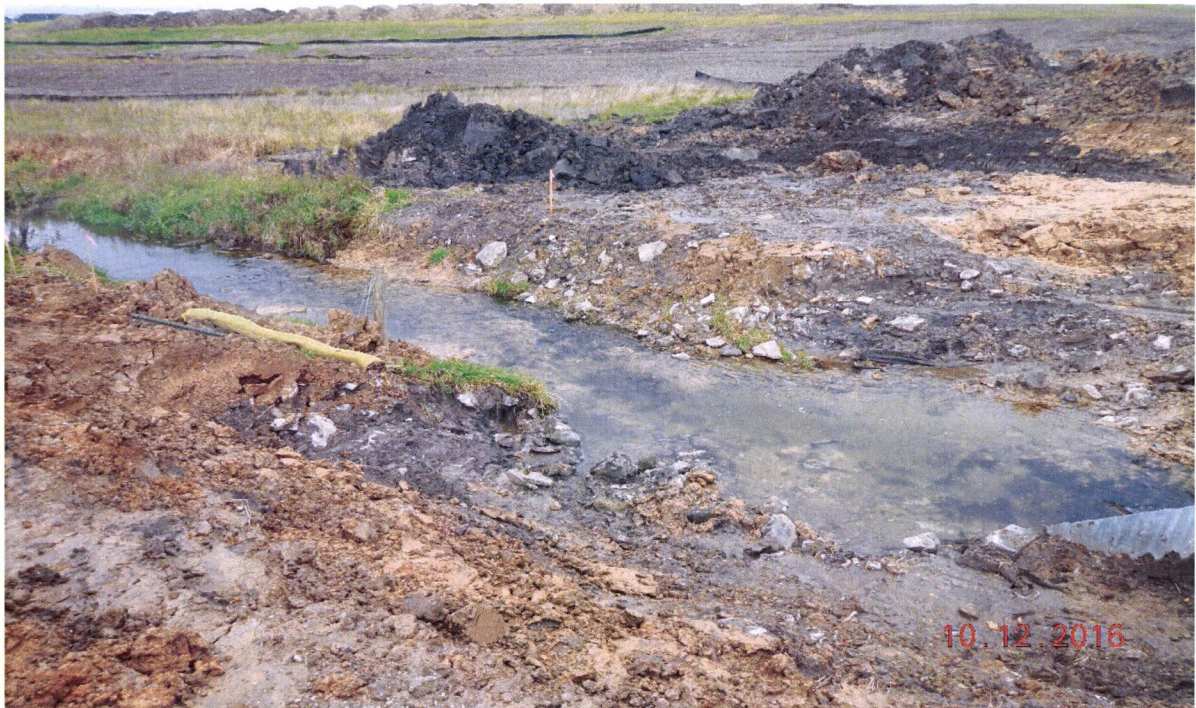
**DSCN1740, Significant sediment in the tributary at the mouth of the culvert.**

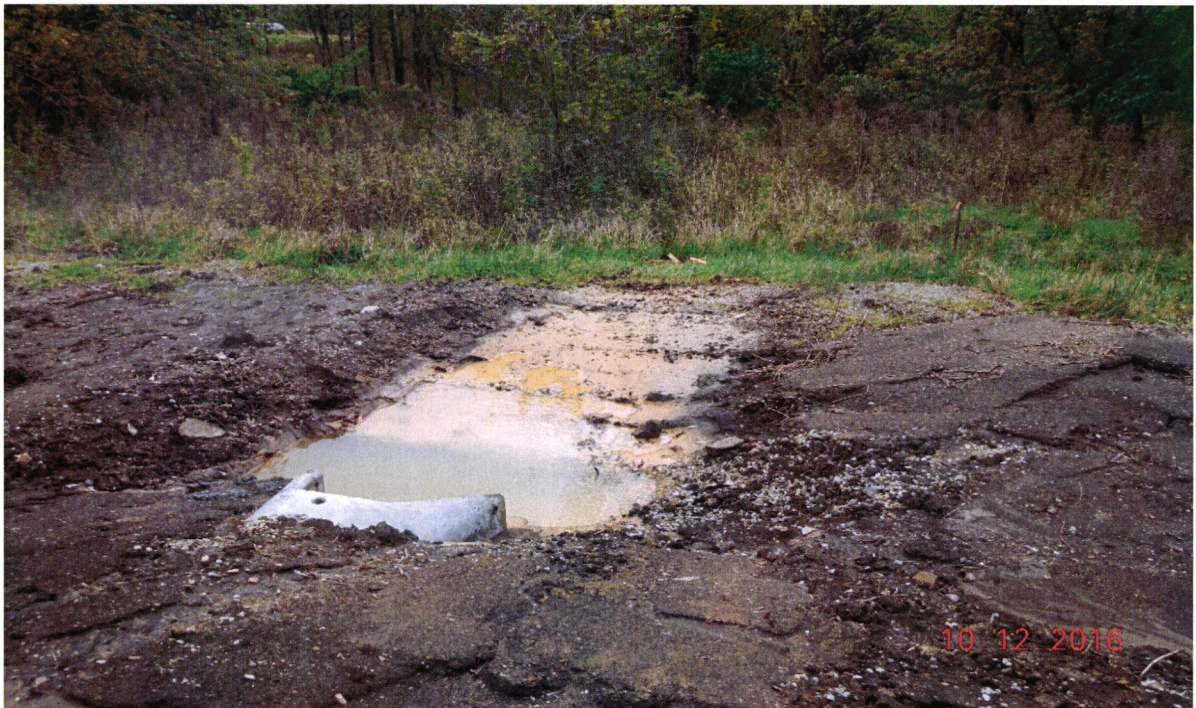
16. I continued walking west through the site away from the tributary and I observed another stormwater outlet (#7 Attachment 2) that had evidence of recent discharge of light colored sediment (DSCN1742). I traced back the outlet pipe to one of two inlets that was recently covered by a metal plate. I continued walking west along the north ditch and I noticed the second storm water inlet (#9) at the bottom of the deep ditch surrounded by light colored sediment similar to that I observed at the mouth of the outlet described above. I also noticed that the collar has recently been installed on the top of stormwater inlet #9.

**DSCN1742, Outlet 7 significant accumulation of sediment leaving the site.**

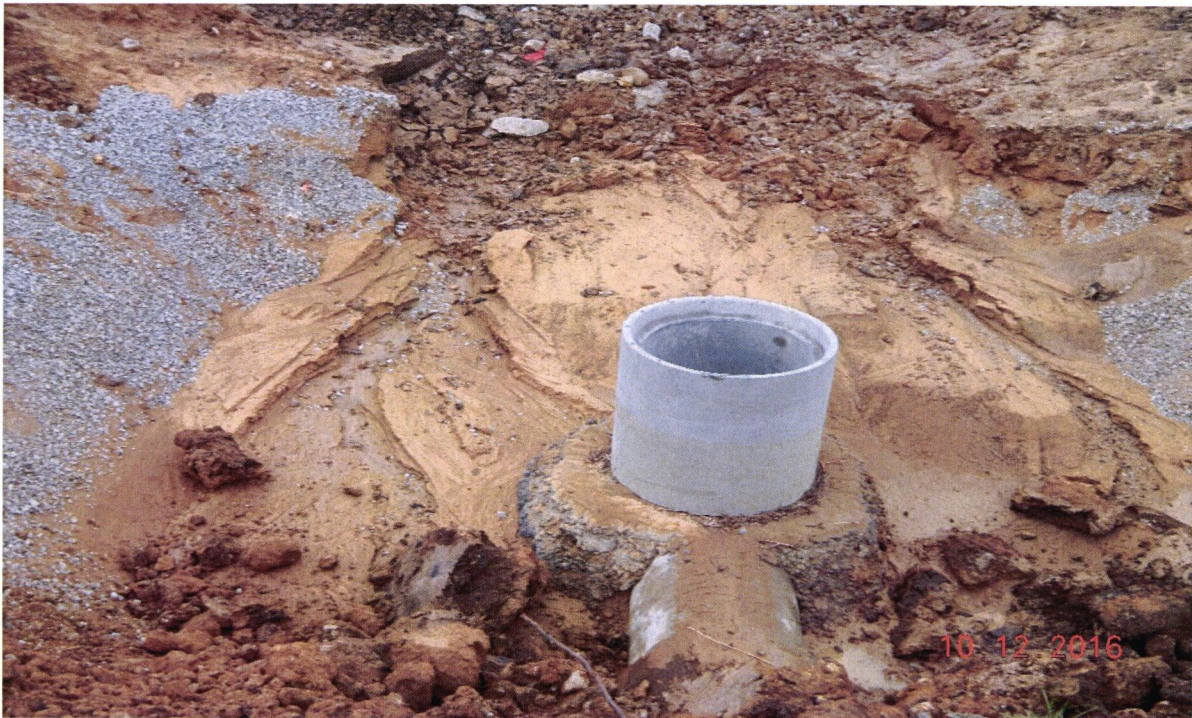
Based on my review of the site plans upon my return to the office, I concluded that the source of the sediment was from a stormwater inlet (#9) in the north ditch of the roadway project (ST18-4, Page 68 of the site plans) as shown in DSCN1752 below.

**DSCN1752, Stormwater inlet #9 with a recently installed collar.**

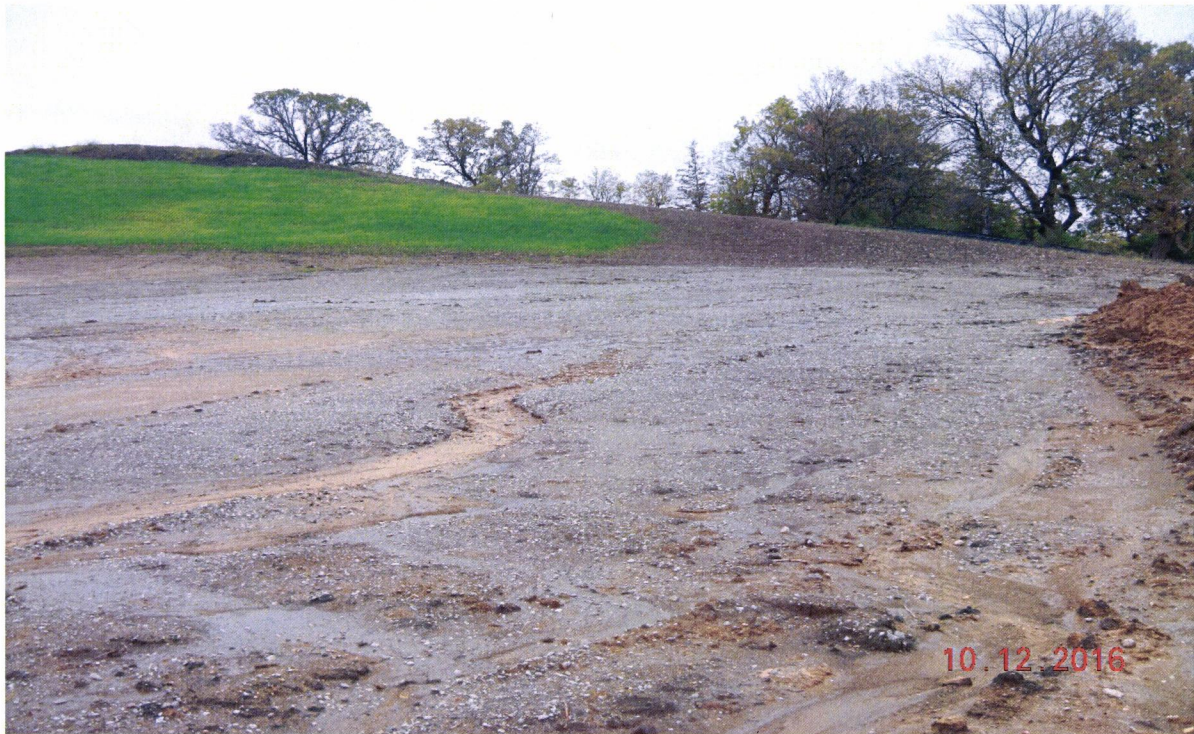
17. I continued my visual observation of the area north stormwater inlet #9 and I noticed that the hillside north of the inlet was disturbed and reseeded (DSCN1751, 1753 and 1754). Mr. Newbury mentioned that this area (west of the pump station) was used as the “borrow” area to elevate the roadway (20 feet). I mentioned to Mr. Newbury that the top of the hillside is well seeded but the bottom area is not. I also pointed out to him evidence of ground erosion that lead to inlet #9 downhill as shown in DSCN1754 below. In addition, upon my return to office, I reviewed the site inspection records. Records indicate that the hillside was hydro seeded during the week of September 5, 2016. Records also indicate that on September 16, 2016, the hydro seed is growing well. Condition D.2.A(1) under Part IV of the Iowa NPDES general permit No. 2 reads, *“A description of temporary and permanent stabilization practices, including site-specific scheduling of the implementation of the practices. Site plans should ensure that existing vegetation is preserved where attainable and that disturbed areas are stabilized. Stabilization practices may include: temporary seeding, permanent seeding, mulching, geotextiles, sod stabilization, vegetative buffer strips, protection of trees, preservation of mature vegetation, and other appropriate measures. Except as precluded by snow cover, stabilization measures shall be initiated on all disturbed areas as soon as practical but in no case where construction activity will not occur for a period of 21 or more calendar days later than the 14th day after no construction activity has occurred on such area. Where the initiation of stabilization measures by the 14th day after no construction activity occurs is precluded by snow cover, then stabilization measures shall be initiated as soon as practicable thereafter”*. According to inspection records, this section of the project exceeded the 21 days requirement. In addition, runoff from the bottom of the hillside area caused sediment deposit in the bottom of the ditch which entered stormwater inlet #9.

**DSCN1754, Borrow area top of the hillside is stabilized but the bottom is eroded.**

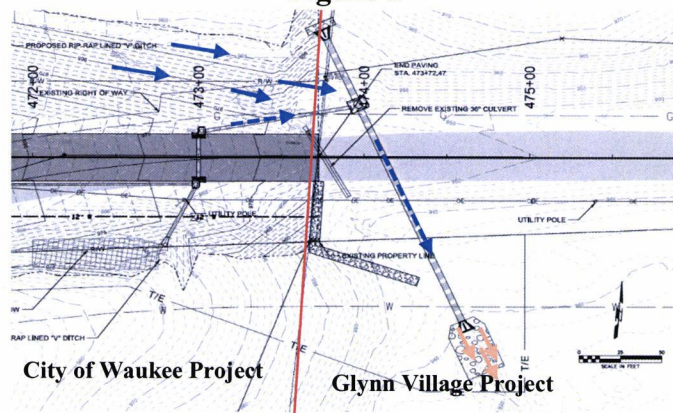
**Figure 1**

DSCN1821-1822. In addition there is sediment coming into inlet #10 from the adjacent City project as shown in Figure 1.

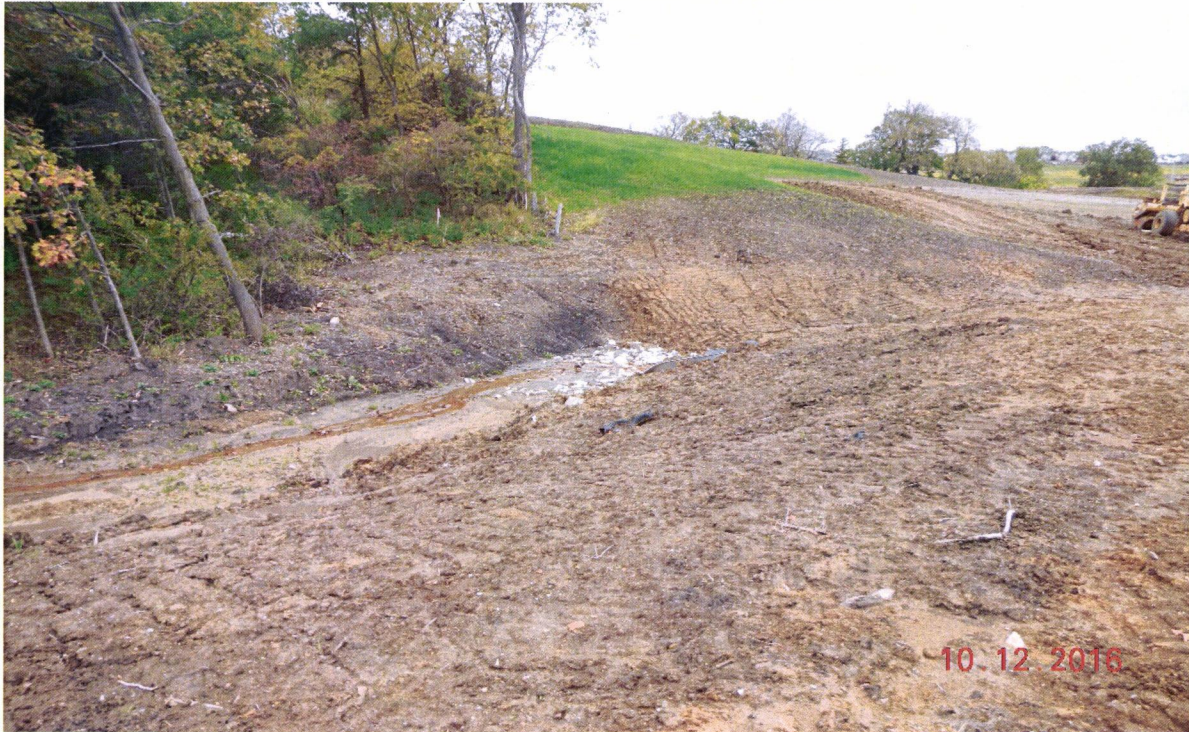
**DSCN1821, Inlet #10 in the north ditch**

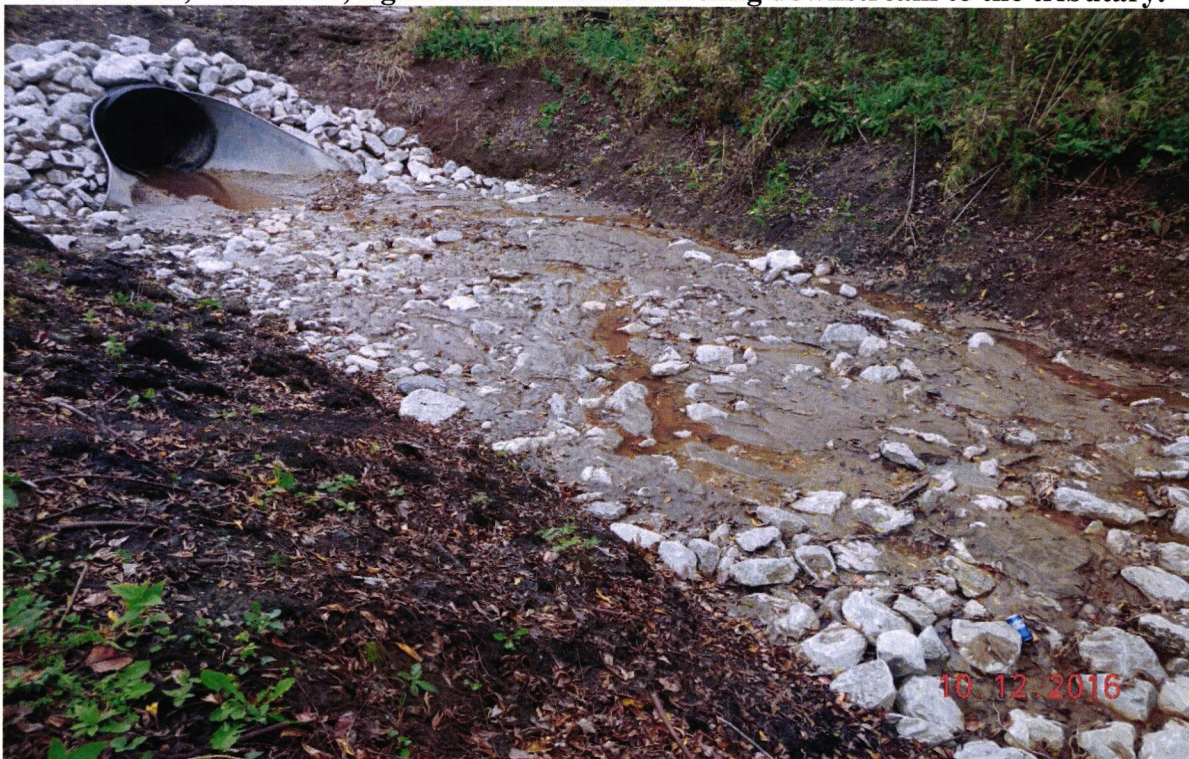
20. I continued walking west approximately 120 yards along the south side of the elevated roadway until I reached another outlet pipe (#10). This outlet has significant sediment accumulation on the ripraps as shown in DSCN1816. The flow to this outlet is mainly from its inlet located in the north ditch (#10). The majority of sediment in the ditch is mainly from the "borrow" area mentioned above and the disturbed north ditch as shown in

**DSCN1816, Outlet #10, significant sediment traveling downstream to the tributary.**

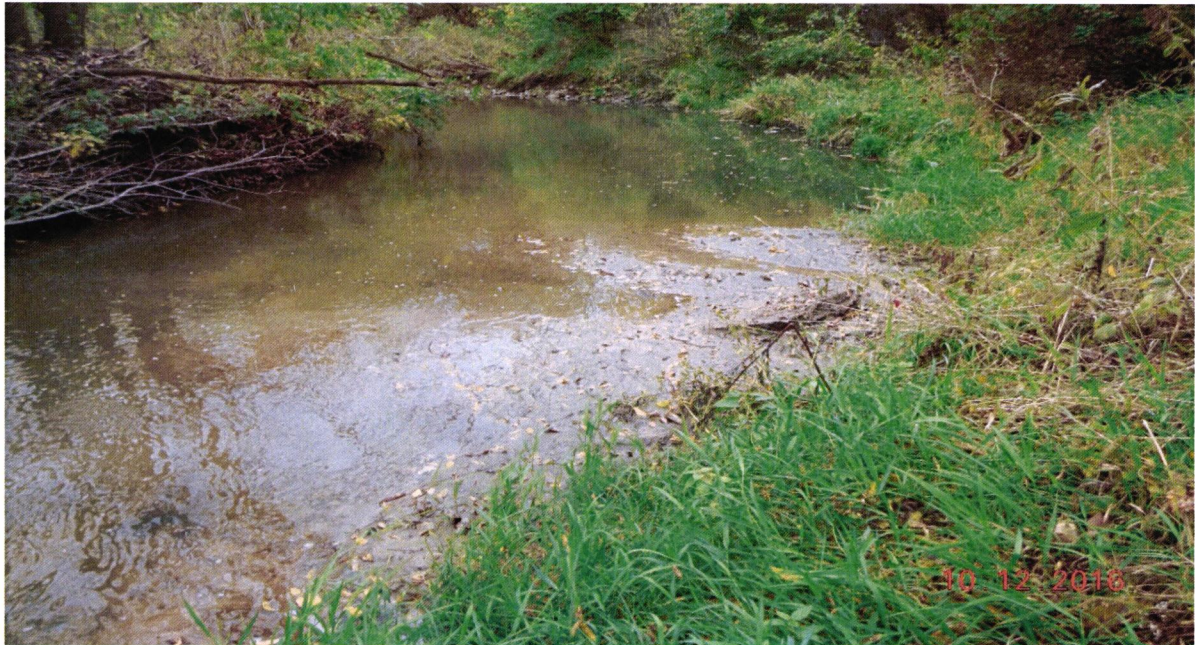
21. I was able to track the sediment (DSCN1805-1808, 1810-812, and 1815-1816) to the tributary as shown in DSCN1808 below.

**DSCN1808, sediment deposit in the tributary to Sugar Creek from outlet #100.**

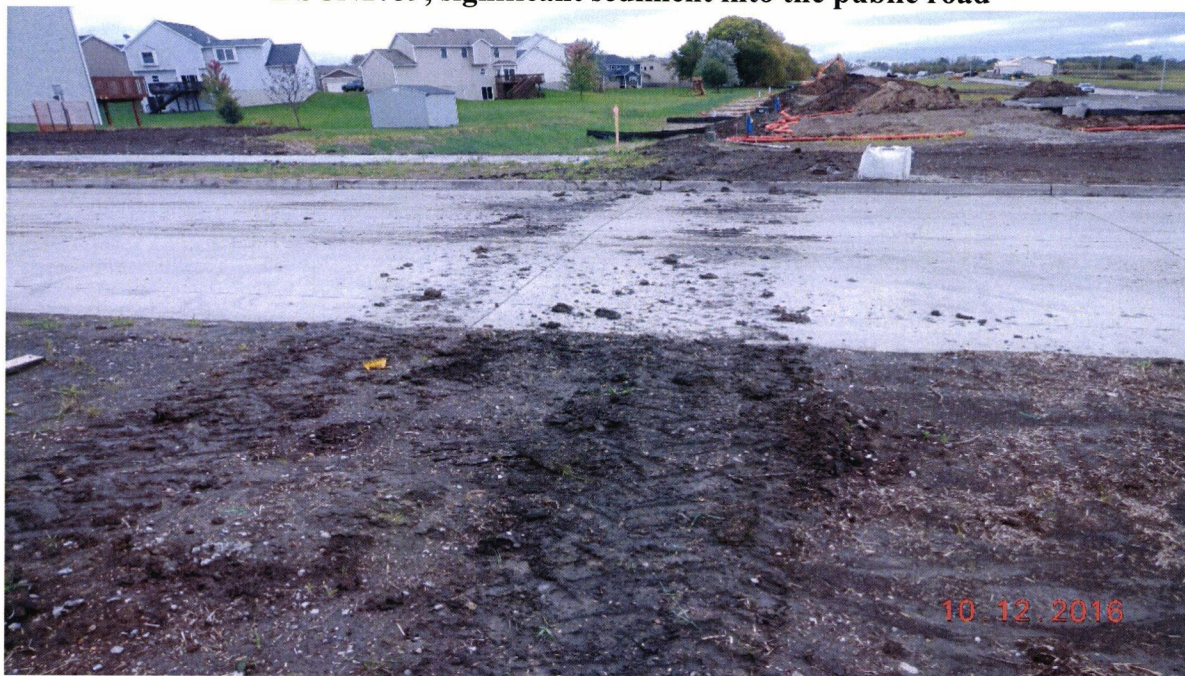
**DSCN1759, significant sediment into the public road**

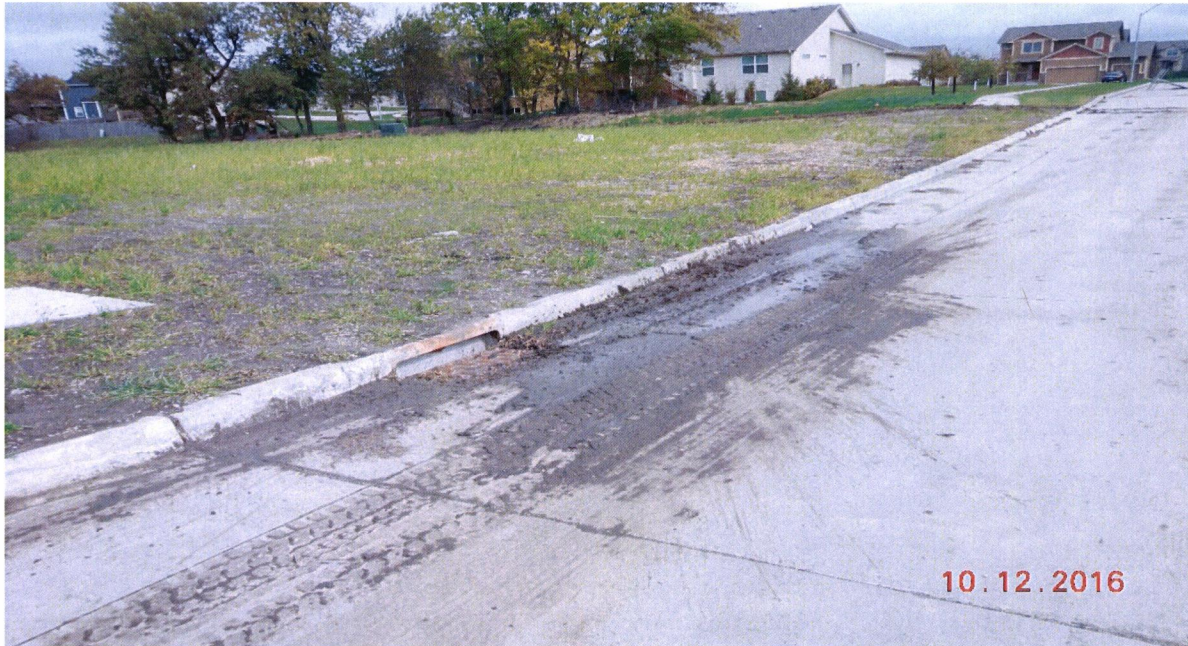
25. Mr. Newbury indicated that they installed silt fabric in all stormwater inlets within the subdivision. The fabric is called Fry-Flow bags and they are 18"x38" in size installed at the bottom of the metal grill of the inlet as shown in DSCN1755 below. Those bags are not adequate enough to prevent sediment from entering the stormwater inlet because they do not cover the entire inlet and because they were not maintained adequately. Most of them were full of sediment and one had vegetation growing in it which indicates lack of maintenance for an extended period of time. Therefore, I issued NOPV #6 because Hubble Development failed to adequately protect the stormwater inlets.

**DSCN1755, Stormwater inlet equipped Fry-Flow Bag**

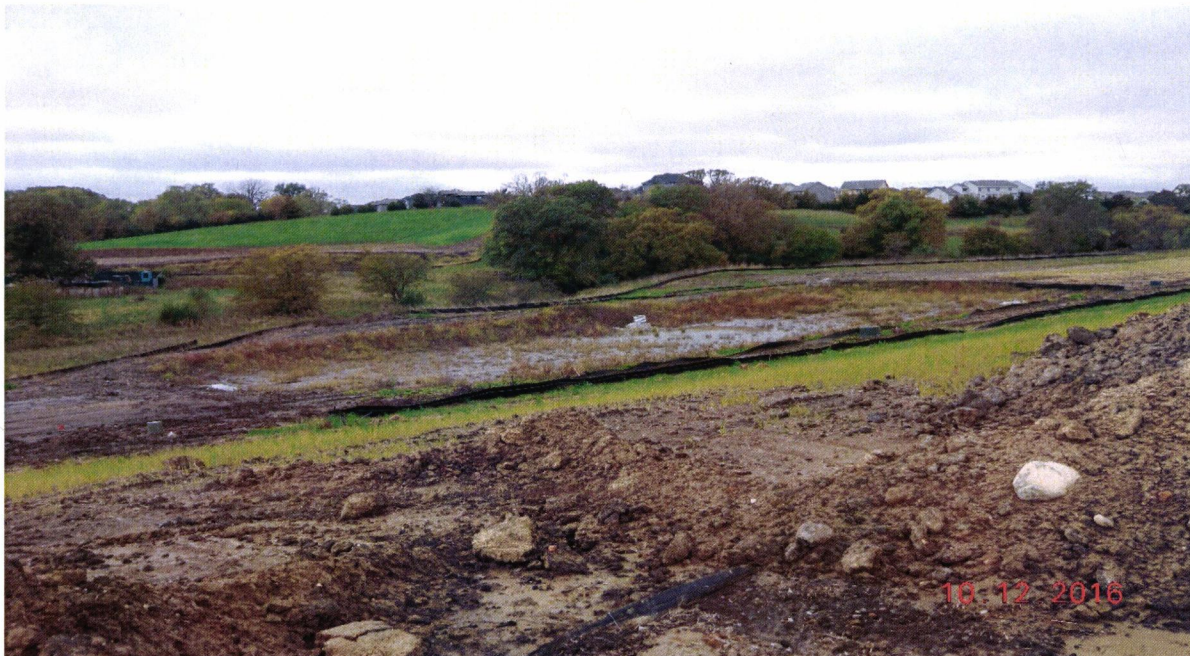
26. The site is designed to direct all surface runoff and stormwater conveyed through stormwater inlets and underground pipes to two sediment basins/ponds. The basins, according to Mr. Newbury, will be permanent stormwater ponds, once the site is developed. I visually inspected the two basins. The basins are referred to as the eastern basin (DSCN1789-1795) which is the larger one and the western basin (DSCN1784-1786). I started by inspecting the small basin and I pointed out to Mr. Newbury the amount of sediment accumulated in the basin as shown in DSCN1785 below. It appeared to me that the basin is not being maintained. I also pointed out to Mr. Newbury that the large sediment basin had significant amount of vegetation growing in it and the west section of its bank is eroded (DSCN1792), and appeared that it has not been maintained for an extended period of time just like the

small basin. Therefore I issued NOPV #7 because Hubble development failed to maintain the two basins.

**DSCN1785, the small basin with significant sediment accumulation**
